Inspection Report

123 Popular St
Anytown, USA

Prepared for: New Home Buyer

Prepared by: Arrow Home Inspection Services, LLC
P.O. Box 37124
Rock Hill, SC 29732

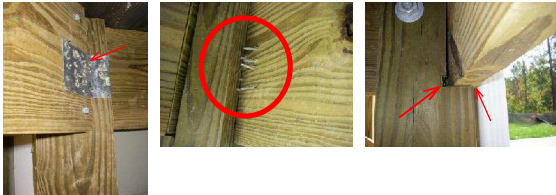
- Walks: Concrete
- Steps/Stoops: Brick
- Patio: Concrete
- Deck: Treated wood Decking material is used in the covered screen porch area, Visible evidence suggests the corner deck strap is not properly fastened in place, Visible rotation in the right rear corner band sill, A qualified licensed contractor is recommended to evaluate the deck framing for any needed repairs

Deck: Treated wood Decking material is used in the covered screen porch area, Visible evidence suggests the corner deck strap is not properly fastened in place, Visible rotation in the right rear corner band sill, A qualified licensed contractor is recommended to evaluate the deck framing for any needed repairs

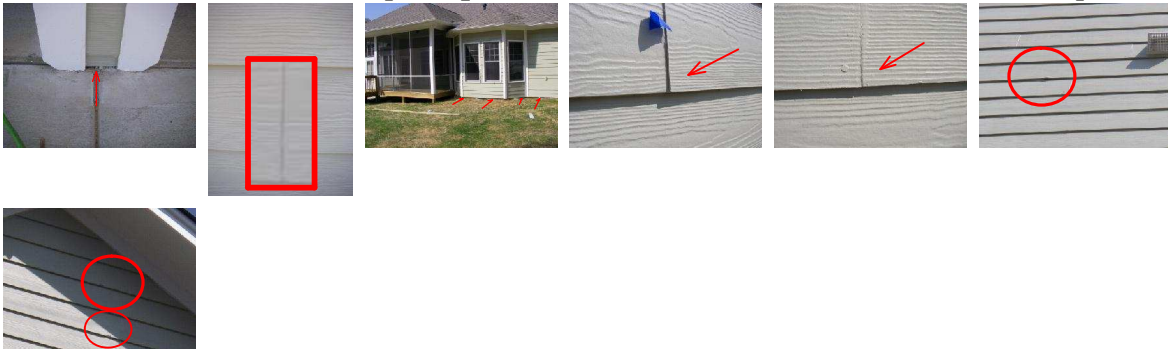
- All walls Exterior Surface
- Type: Hardy Plank/ Cement Board Evidence suggests the siding in the middle post of the garage doors and on the rear wall may not have sufficient minimum clearance to the finished grade (6" min clearance is typical), Minimum clearances should be maintained per the siding manufacturer's specifications The butt-end joints in the siding panels are varied in the siding application, It should be determined that the wider gaps in these joints do not exceed the allowable gap per the manufacturer's specifications, Loose siding panels and missing siding nails along the right side wall, Siding should be fastened per the manufacturer's specifications, Damaged siding on the right side wall, Recommend evaluation by a qualified licensed contractor for any needed repairs

All walls Exterior Surface Type: Hardy Plank/ Cement Board Evidence suggests the siding in the middle post of the garage doors and on the rear wall may not have sufficient minimum clearance to the finished grade (6" min clearance is typical), Minimum clearances should be maintained per the siding manufacturer's specifications
The butt-end joints in the siding panels are varied in the siding application, It should be determined that the wider gaps in these joints do not exceed the allowable gap per the manufacturer's specifications, Loose siding panels and missing siding nails along the right side wall, Siding should be fastened per the manufacturer's specifications, Damaged siding on the right side wall, Recommend evaluation by a qualified licensed contractor for any needed repairs

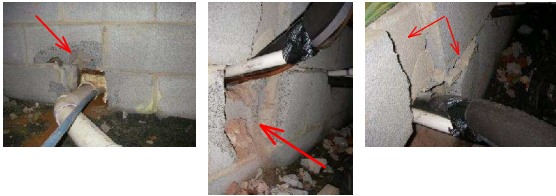
- Structure Type: Wood frame Limited access due to finished construction
- Foundation: Brick, Block Visible damage to the foundation wall where the drain pipes penetrate the front wall and where the refrigerant lines penetrate the right side wall , Recommend evaluation by a qualified licensed contractor for any needed repairs, Limited visibility due to finished grade

Foundation: Brick, Block Visible damage to the foundation wall where the drain pipes penetrate the front wall and where the refrigerant lines penetrate the right side wall, Recommend evaluation by a qualified licensed contractor for any needed repairs, Limited visibility due to finished grade

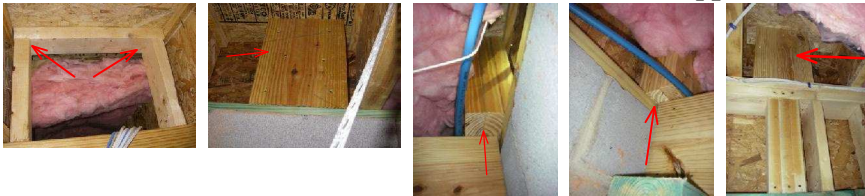
- Bearing Walls: Not visible Access obstructed by finished construction
- Joists/Trusses: Engineered floor joists Squash blocks are improperly installed along the interior girder, The position of the squash blocks places the load bearing along the weakest axis/dimension of the 2x4, Squash blocks should be installed per joist manufacturer specifications and where needed along the load paths , Squash block near the half-bath area is improperly oriented, Typical manufacturer specs call for the blocks to be installed parallel to the joists, Squash blocks on the front end of an interior girder are wider than the supporting girder, Recommend evaluation by a qualified licensed contractor, Limited access due to batt-type floor insulation

Joists/Trusses: Engineered floor joists Squash blocks are improperly installed along the interior girder, The position of the squash blocks places the load bearing along the weakest axis/dimension of the 2x4, Squash blocks should be installed per joist manufacturer specifications and where needed along the load paths , Squash block near the half-bath area is improperly oriented, Typical manufacturer specs call for the blocks to be installed parallel to the joists, Squash blocks on the front end of an interior girder are wider than the supporting girder, Recommend evaluation by a qualified licensed contractor, Limited access due to batt-type floor insulation

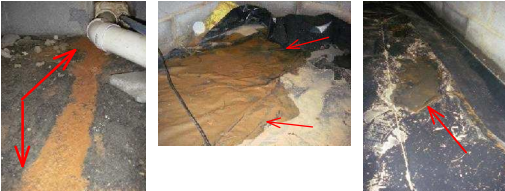
Moisture Location: Front wall

- Moisture Penetration:** Yes Water entry noted around the drain pipe penetration in the front wall, The foundation wall should be properly sealed on both sides of the wall to prevent moisture intrusion into the crawl space area, Pooling water along the right side wall, Recommend evaluation by a qualified licensed contractor for any needed repairs

Side wall access Crawl Space Moisture Penetration: Yes Water entry noted around the drain pipe penetration in the front wall, The foundation wall should be properly sealed on both sides of the wall to prevent moisture intrusion into the crawl space area, Pooling water along the right side wall, Recommend evaluation by a qualified licensed contractor for any needed repairs
