Home Inspection Report

123 Main St
My Town, USA

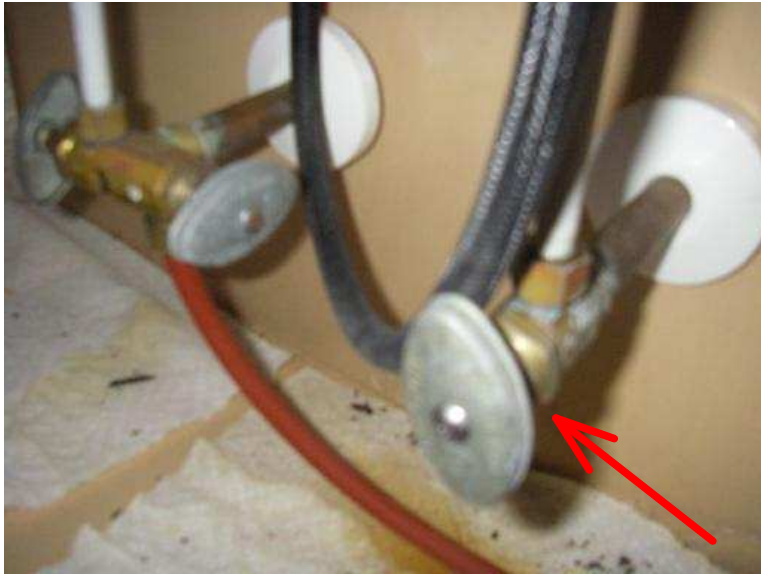
Leak at cold water valve (kitchen sink)

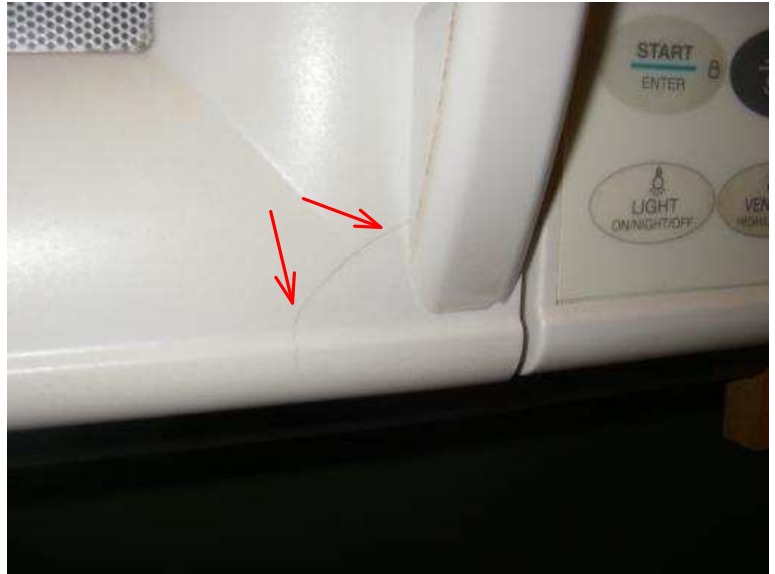
Microwave door is cracked

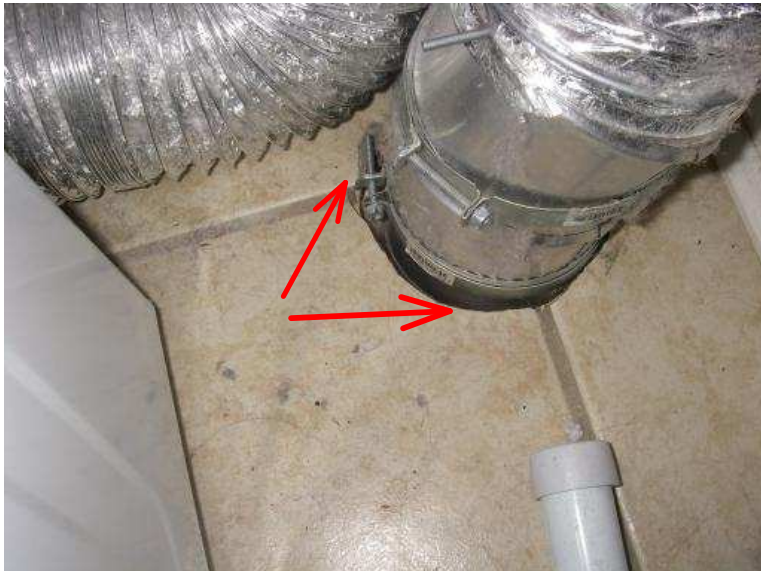
Properly seal penetrations in the flooring in: laundry room

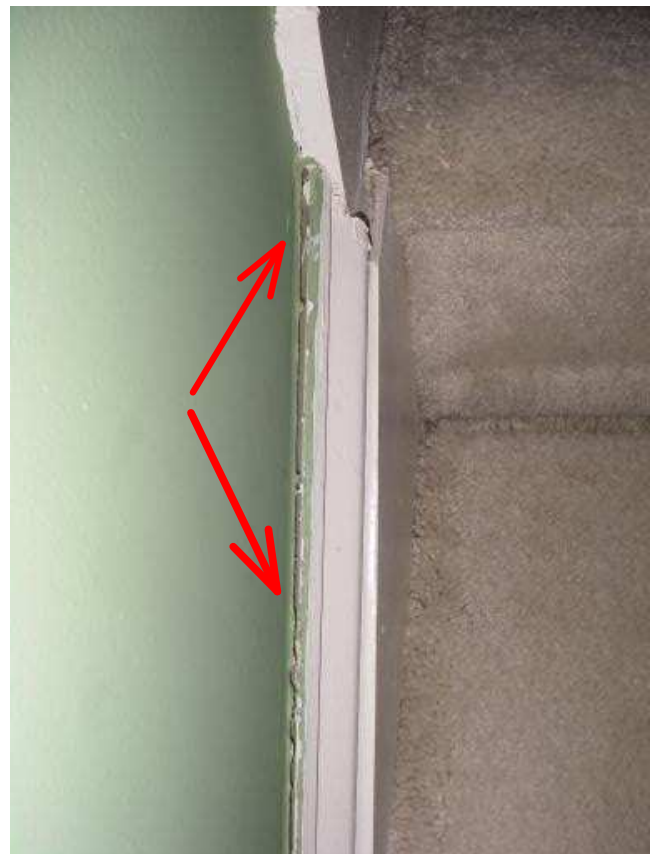
Loose trim at the bottom landing (right side stairs)

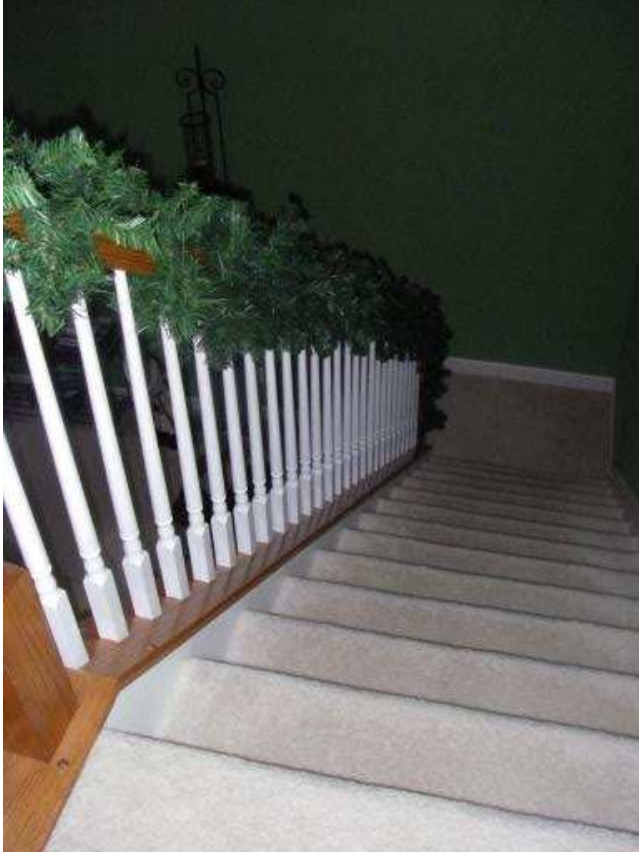
Loose handrails right side stairs

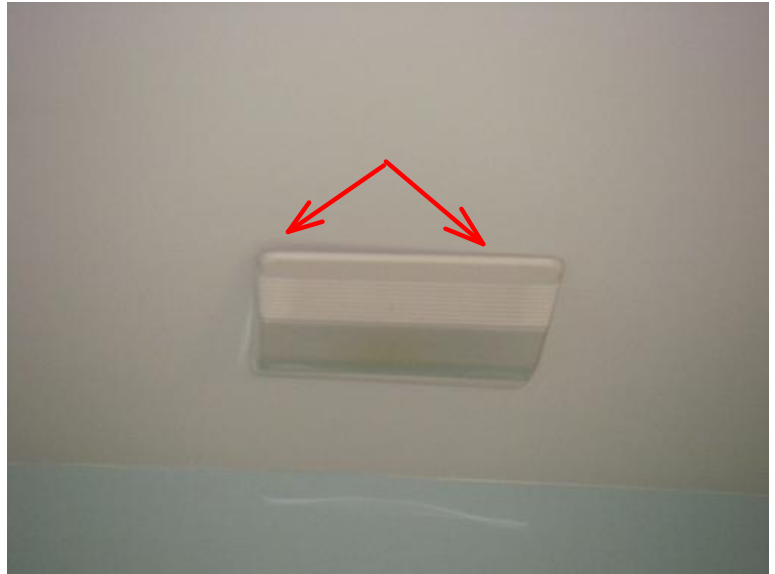
Loose fan at ceiling level in 2nd floor bath

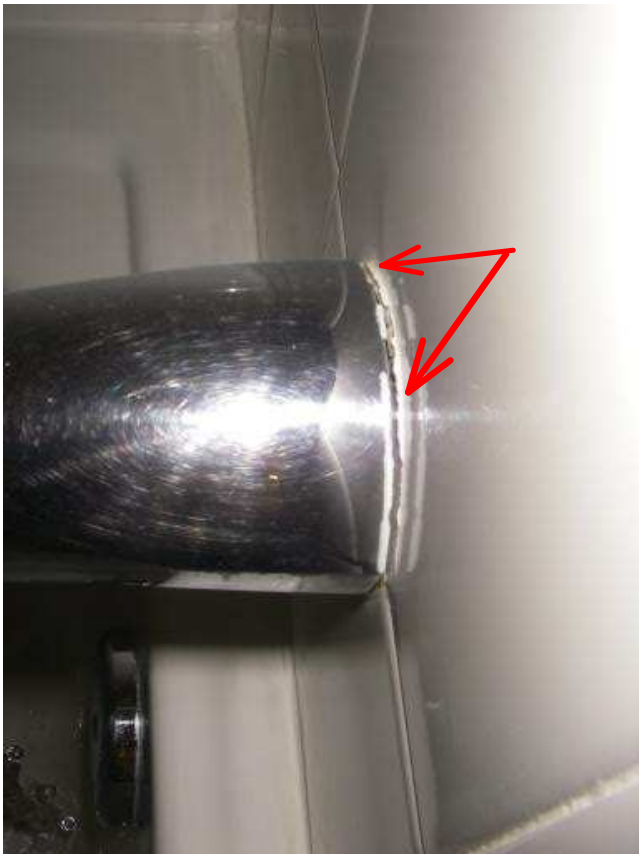
Tub fixture needs caulking

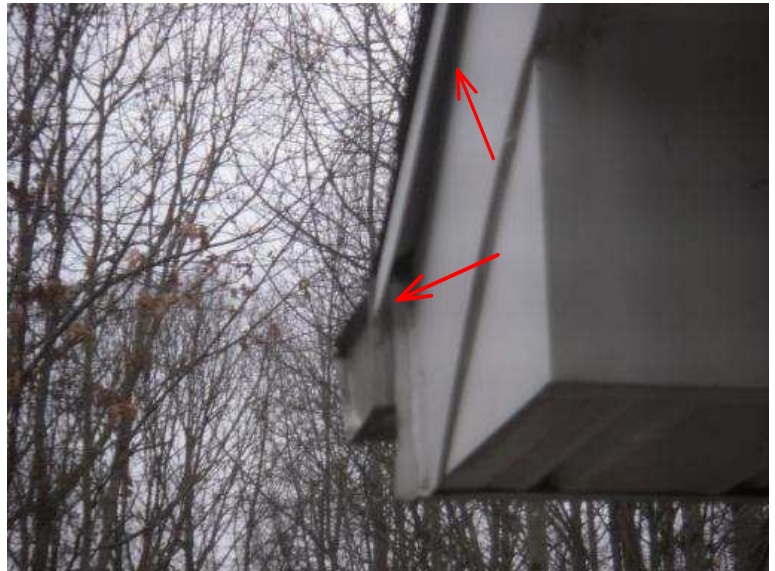
Loose fascia rear wall

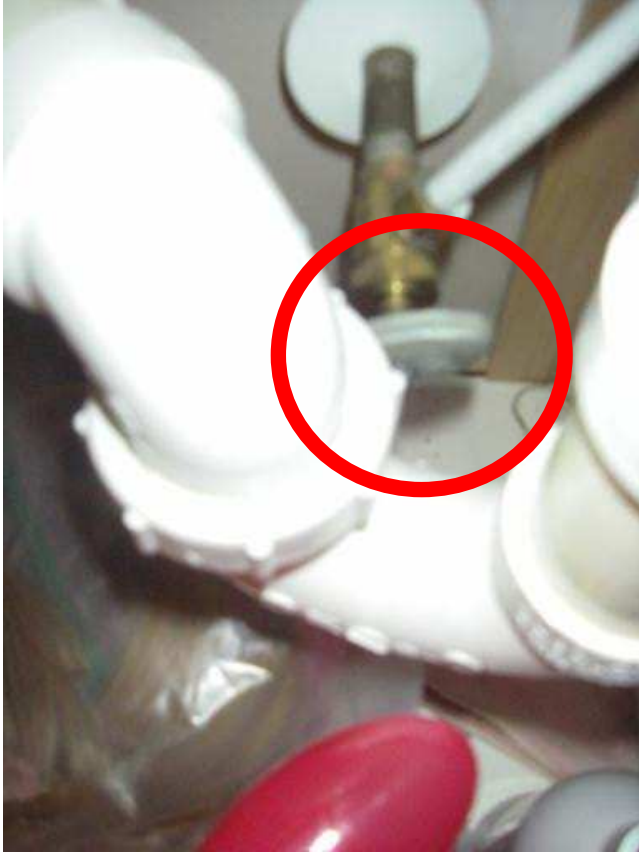
The cold water valve in contact with drain pipe

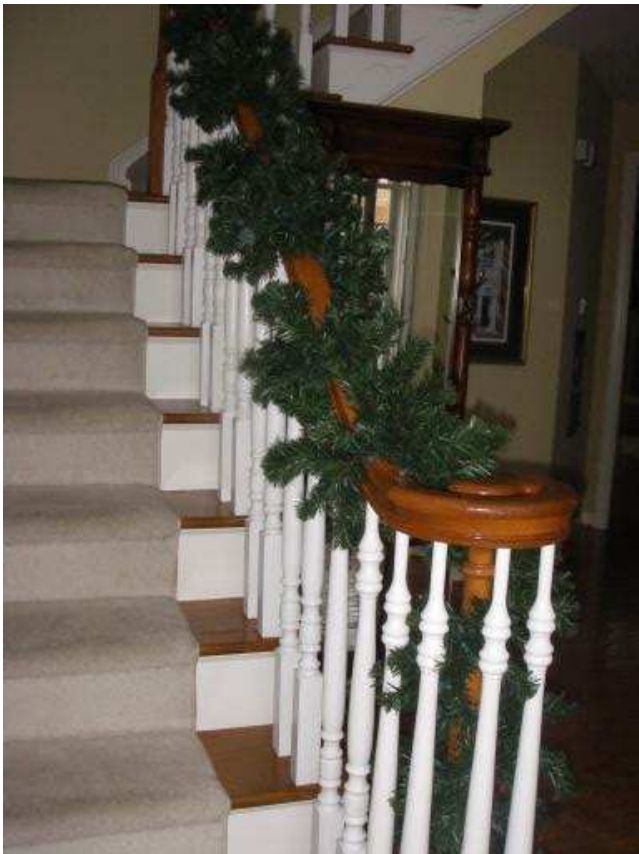
Loose handrails along stairs

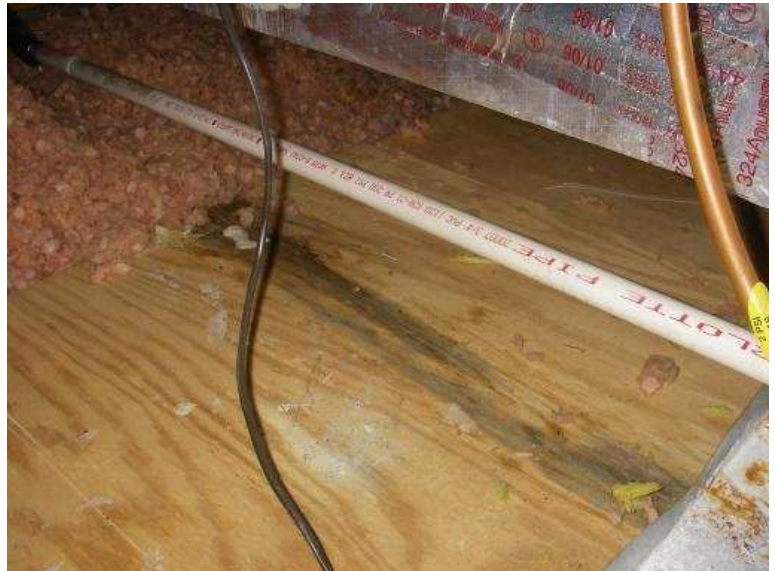
Evidence suggests the condensate drain pipes are dripping in the attic

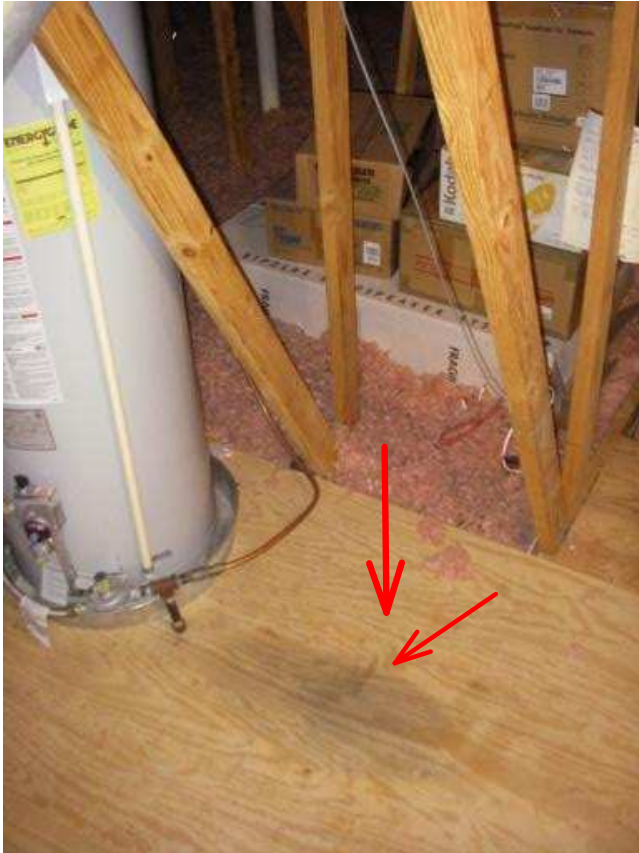
Evidence of prior moisture intrusion below the furnace exhaust stack in the attic.

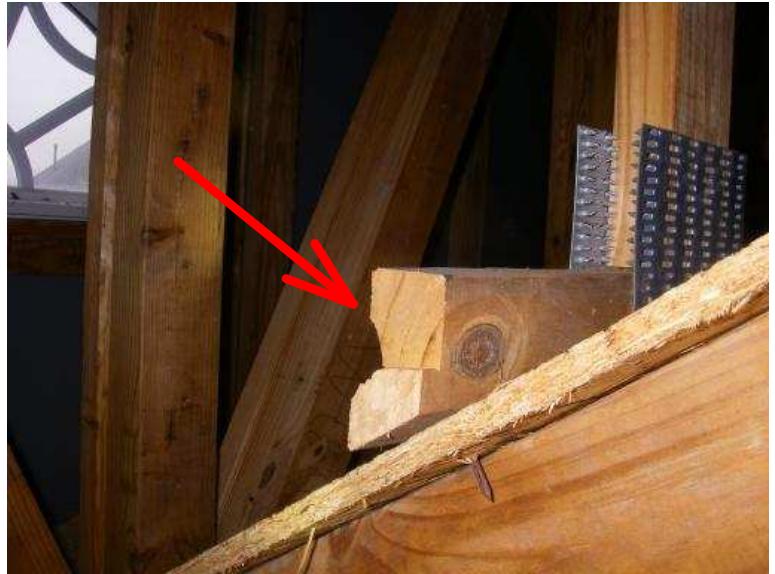
Front Gable (Attic) - Roof truss bottom chord has been cut-in-two.

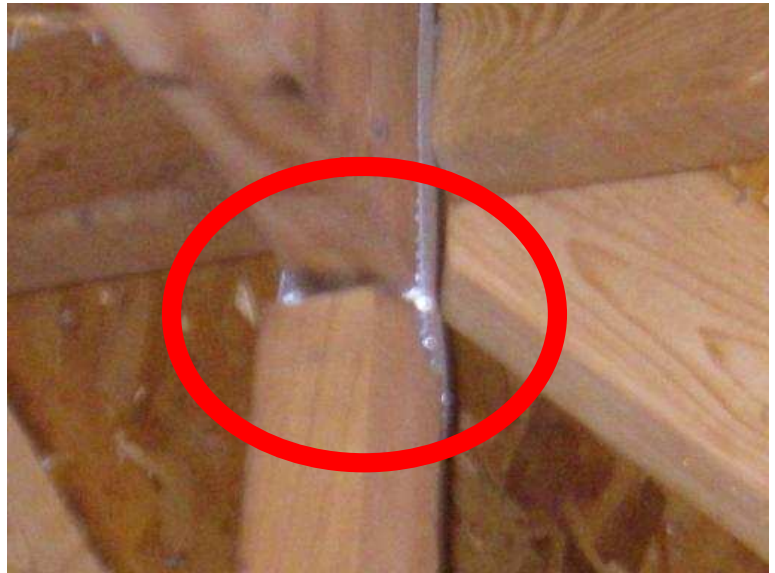
Main Attic Area -, Loose/damaged truss plate on the roof truss (1st truss to the right if the right end hip intersection)

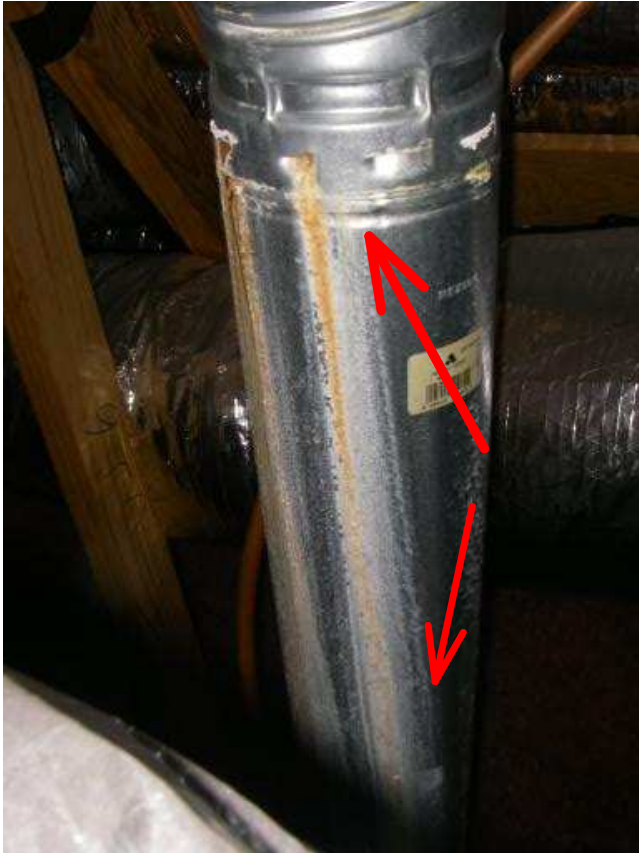
Rust is present along the furnace exhaust stack (in attic)

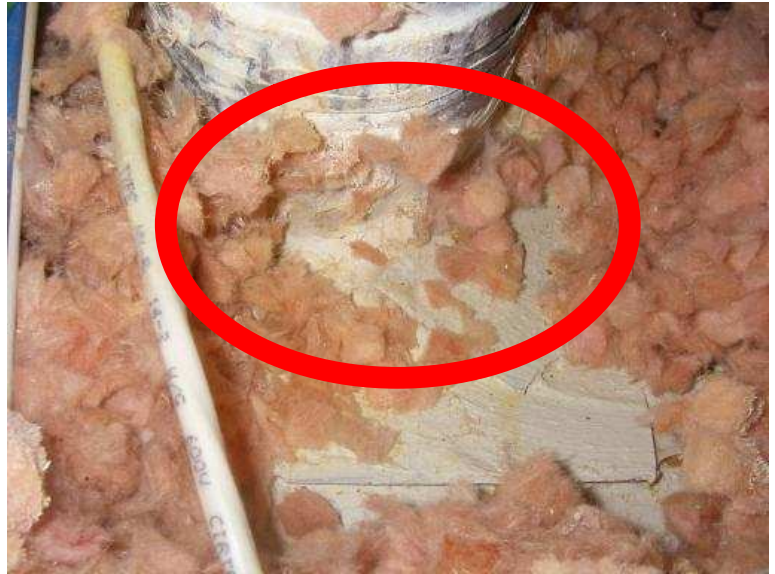
The ceiling is wet at the bottom of the furnace exhaust stack in the attic area

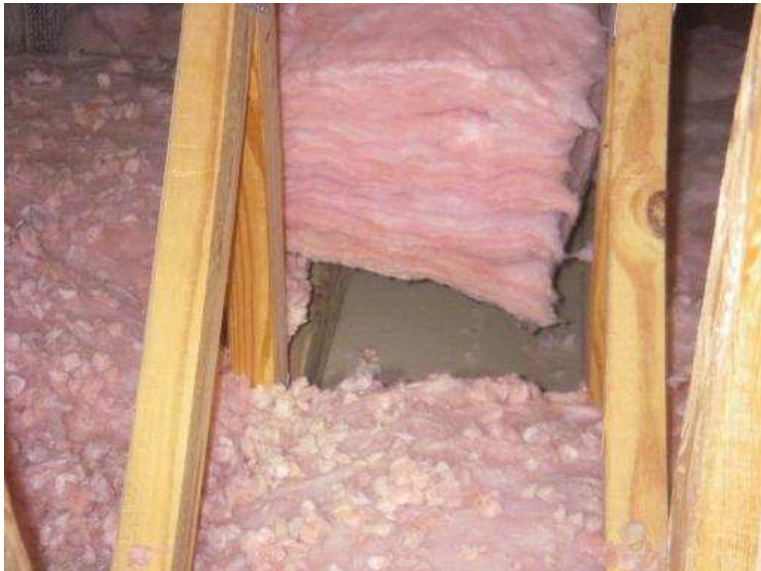
Some of the batt insulation is improperly installed (loose, front slope side in attic)

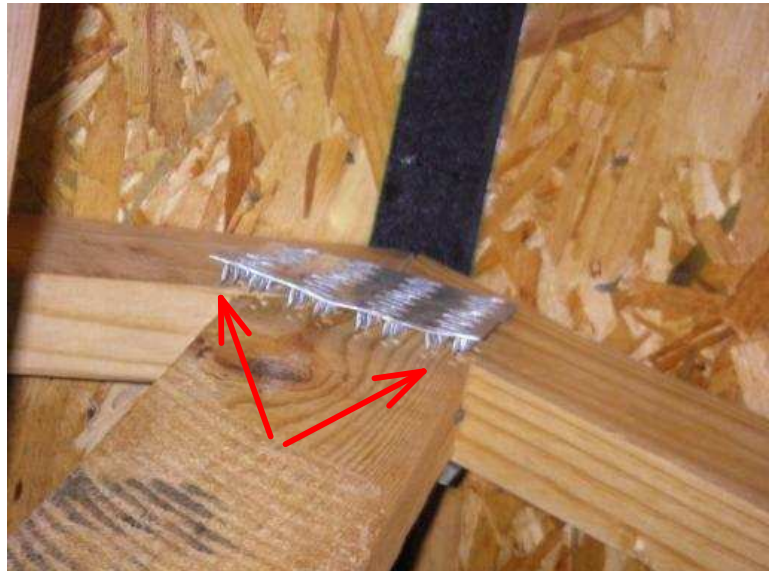
Main Attic Area - Loose/damaged truss plate on the roof truss

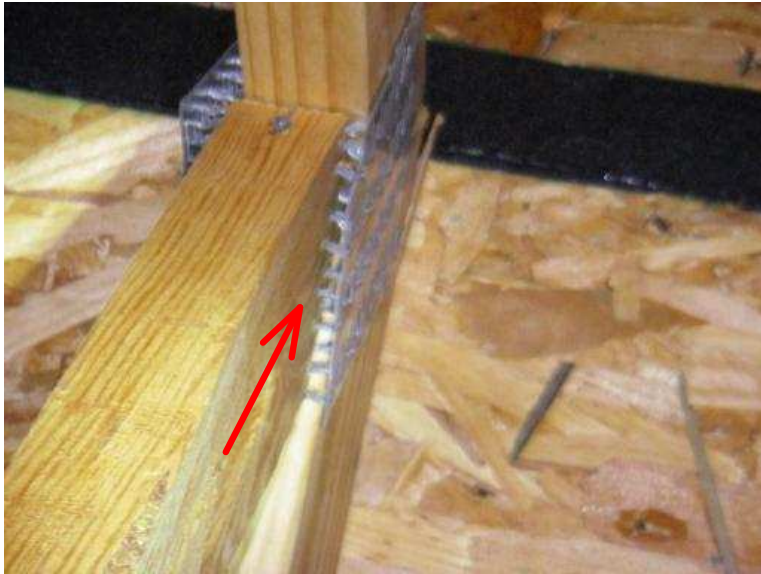
Loose truss plates on roof truss

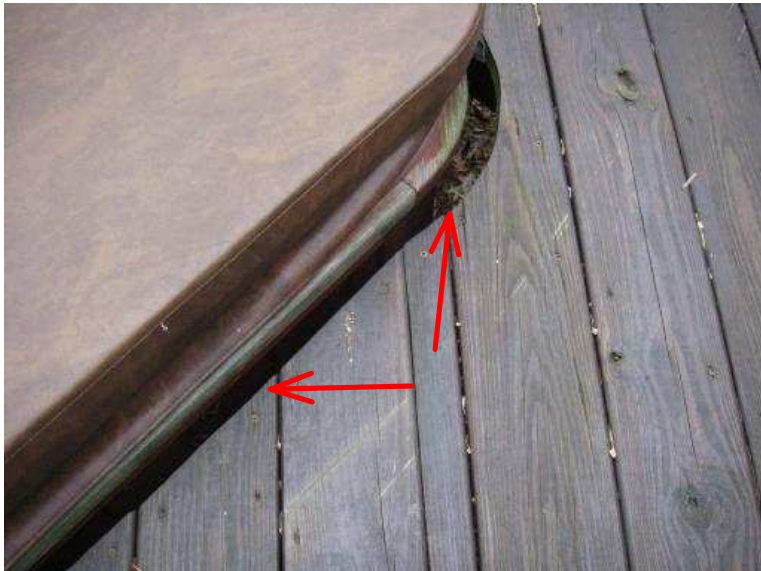
FYI - Gap between the hot tub and deck can and may pose a step through hazard for a small child.

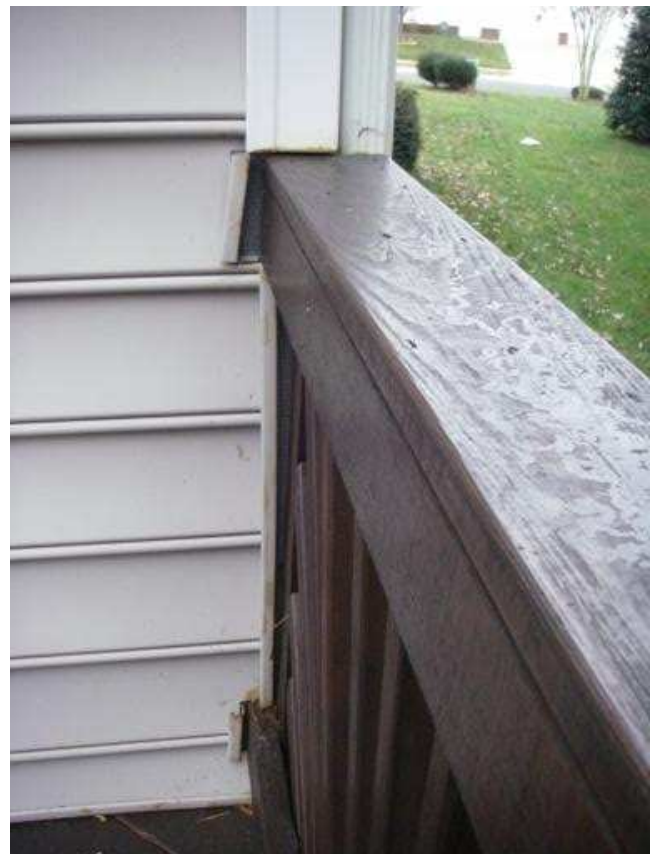
Deck rails are loose and need securing.

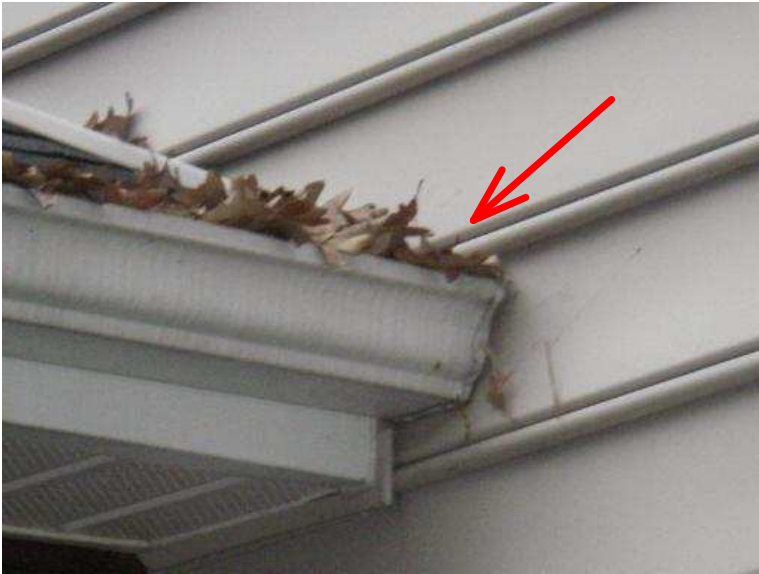
There is no visible kick-out flashing at the bottom junctions of the lower roof slopes and house

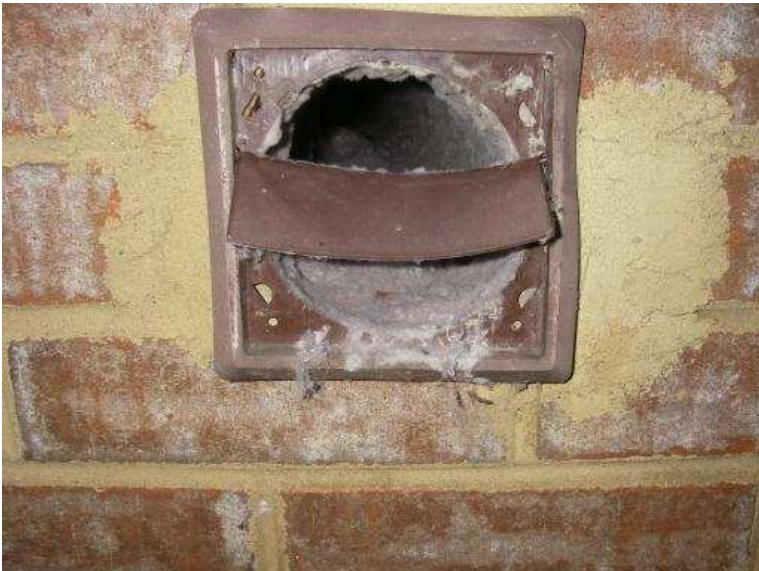
The exterior dryer vent cover is damaged

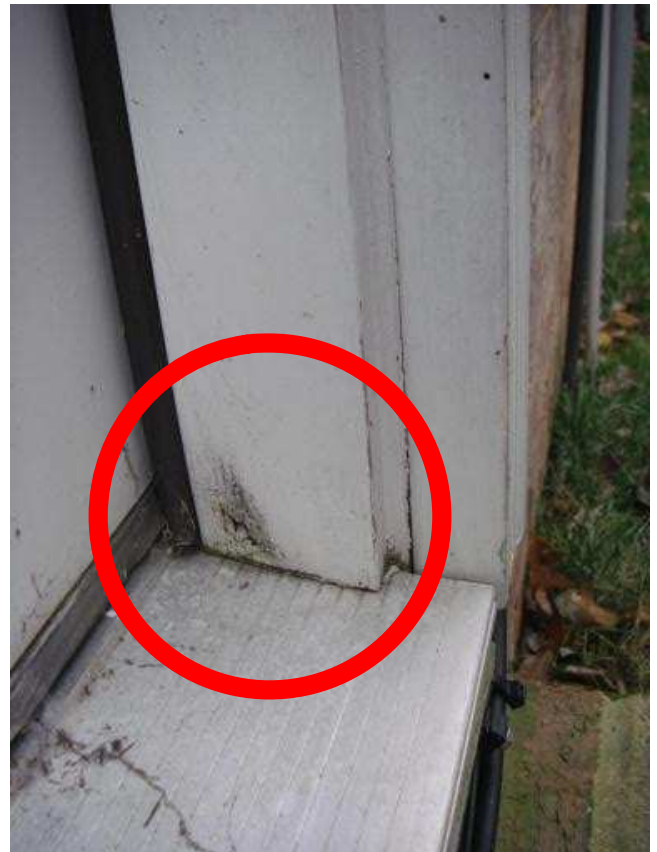
Damaged trim /frame at the right side garage service door

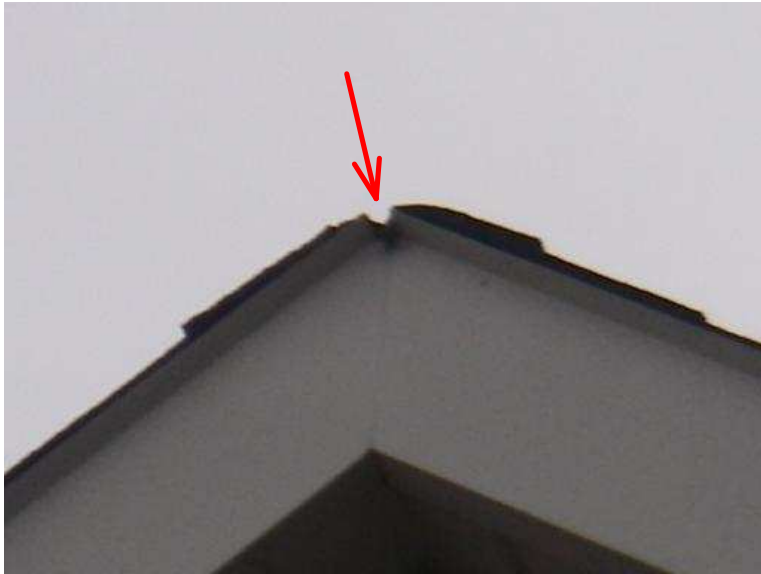
Ridge cap shingles are split on the front gable ends

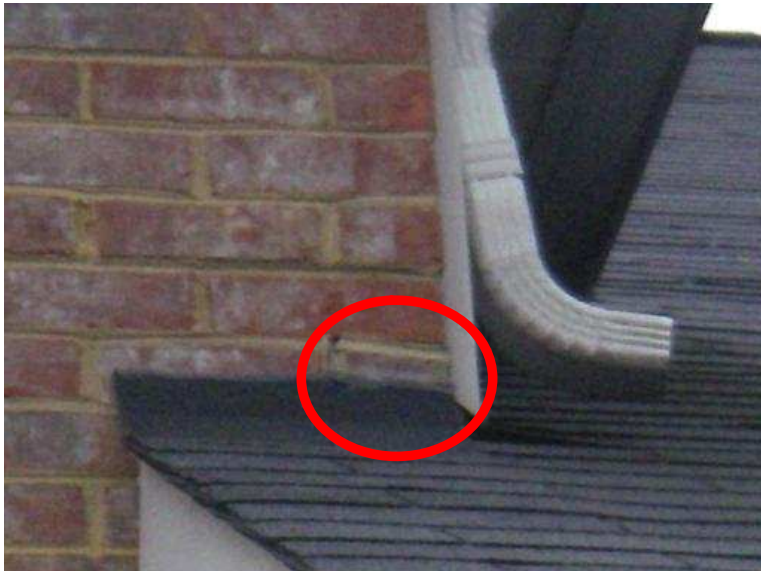
Loose brick at the right front corner of the wall-to-roof area and flashing

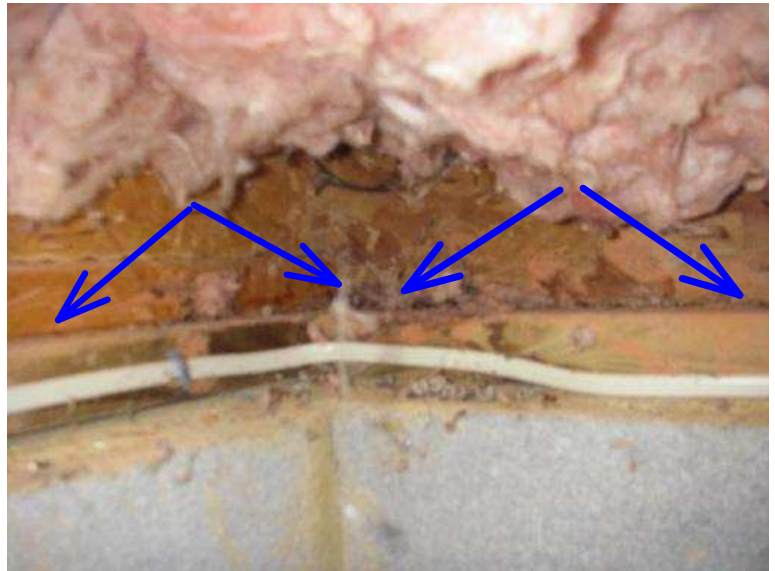
Anchor straps /bolts are not visible within 12 inches of some of the corners in the crawl space

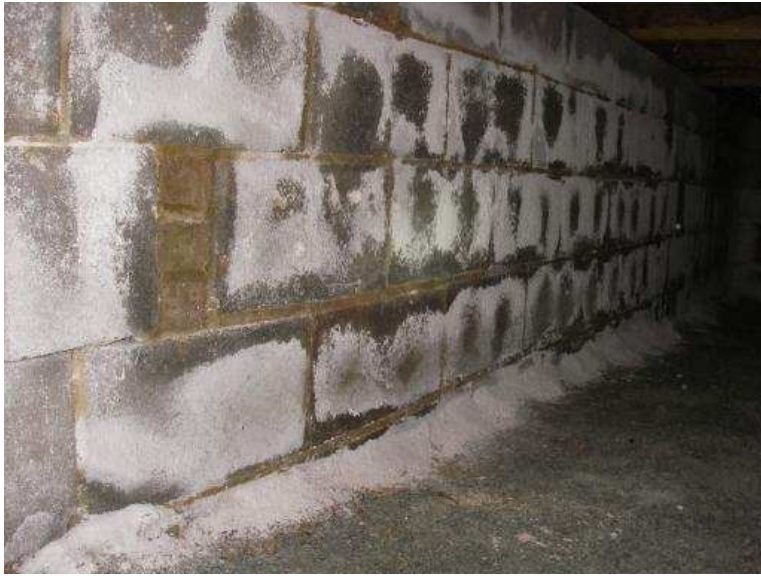
Efflorescence was observed on the foundation walls

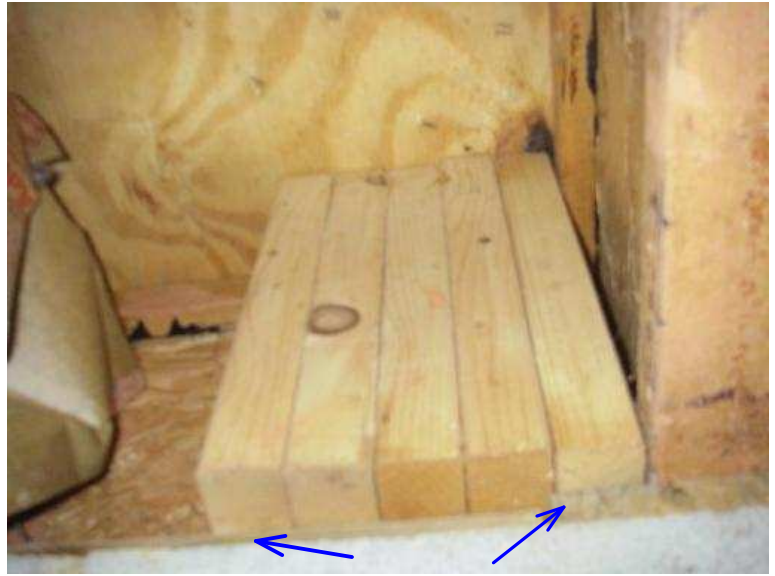
Squash blocks overlap the supporting sole plate, Typically the base support is the same width as the supported framing.
