Inspection Report

123 Main St
Anytown, USA

Prepared by: Arrow Home Inspection Services, LLC
P.O. Box 37124
Rock Hill, SC 29732

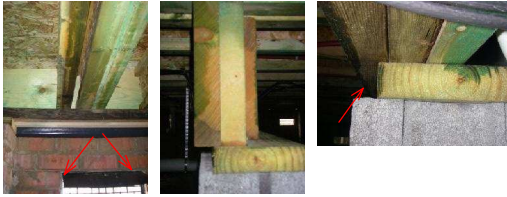
- Piers/Posts:** Block piers There is no pier support under the end of an interior girder on the left side wall, Can and may be prone to arching action in the foundation wall section above the vent, Improper shimming supports on the piers, Recommend improved shimming, Recommend evaluation by a qualified licensed contractor

Piers/Posts: Block piers There is no pier support under the end of an interior girder on the left side wall, Can and may be prone to arching action in the foundation wall section above the vent, Improper shimming supports on the piers, Recommend improved shimming,

Recommend evaluation by a qualified licensed contractor

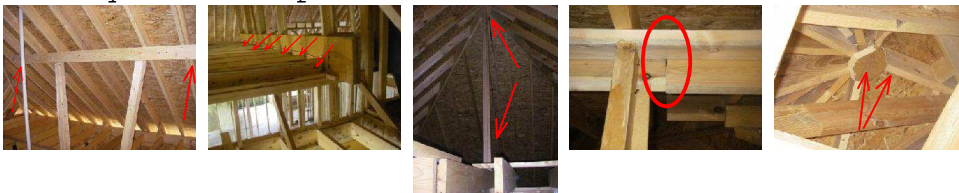
- Unable to Inspect:** 30% Roof line, Height in the attic area
 Roof Framing: Rafter Missing supports for the purlin braces along the gable end walls, Purlin brace supports are typically installed at no more than maximum spacing of 4 feet on center along the purlin brace, Unsupported splice joint in the purlin along the rear slope above the kitchen area, Evidence suggests the ceiling joists fastened to the LVL are less than 60% of the height of the supporting LVL plies, The LVL spanning the rear area needs bracing on each side of the LVL, Spacing of these braces are typically 24 inches on center or less and are needed on both sides of the LVL, Visible evidence suggests the longest ridge board support (center of house) is at or near its maximum length for the dimensional lumber used (2x4), If this support exceeds its allowable maximum height (14'-7"), the next larger dimensional size lumber should be installed (2x6), Above the breakfast room there is no visible ridge support for the room framing, Recommend evaluation by a qualified licensed contractor for any needed repairs

Upstairs room Attic Roof Framing: Rafter Missing supports for the purlin braces along the gable end walls, Purlin brace supports are typically installed at no more than maximum spacing of 4 feet on center along the purlin brace, Unsupported splice joint in the purlin along the rear slope above the kitchen area, Evidence suggests the ceiling joists fastened to the LVL are less than 60% of the height of the supporting LVL plies, The LVL spanning the rear area needs bracing on each side of the LVL, Spacing of these braces are typically 24 inches on center or less and are needed on both sides of the LVL, Visible evidence suggests the longest ridge board support (center of house) is at or near its maximum length for the dimensional lumber used (2x4), If this support exceeds its allowable maximum height (14'-7"), the next larger dimensional size lumber should be installed (2x6), Above the breakfast room there is no visible ridge support for the room framing, Recommend evaluation by a qualified licensed contractor for any needed repairs
